SAS Superstructure

Daily Diary Report by Bid Item

Diary #: 369 Const Calendar Day: 701 Date: 10-Aug-2011 Wednesday

04-0120F4
04-SF-80-13.2/13.9
Self-Anchored
Suspension Bridge

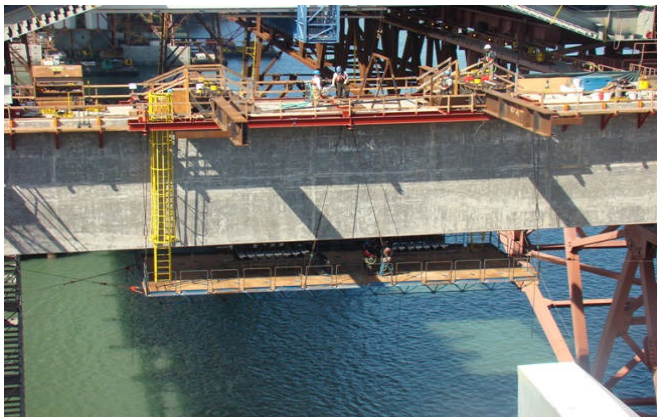
The continued placement of the S3 and S4 Shear Key anchor rods which are supported at the bottom of the E2 cap beam.

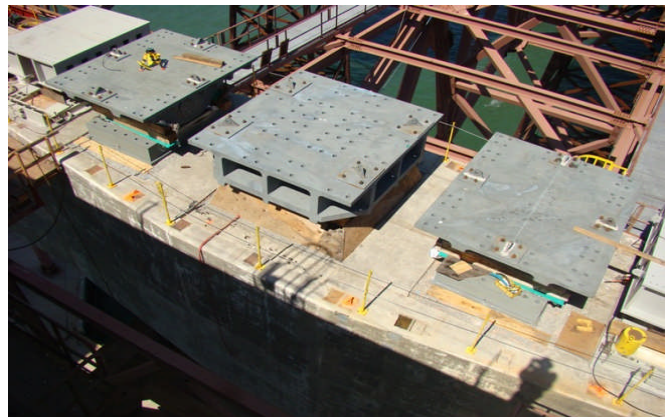
Protective covers placed over the holes for the S2 Shear Key to prevent debris from getting into the anchor rod blackout.

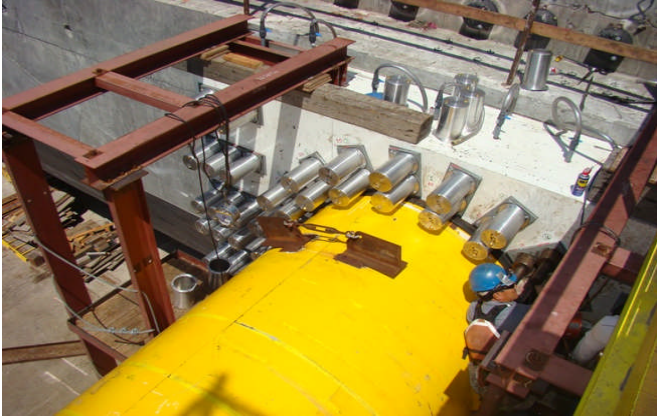
Continued placement of the aluminum caps at the end of the Macalloy rods for the North W2E Hinge K pipe beam assembly.

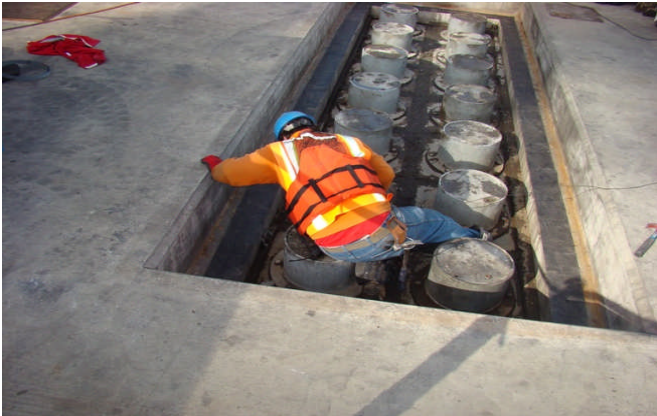
ABF laborer seen cleaning the drainage pipe in the blockout. The laborers also cleaned the concrete surfaces with a wire brush and placed the neoprene

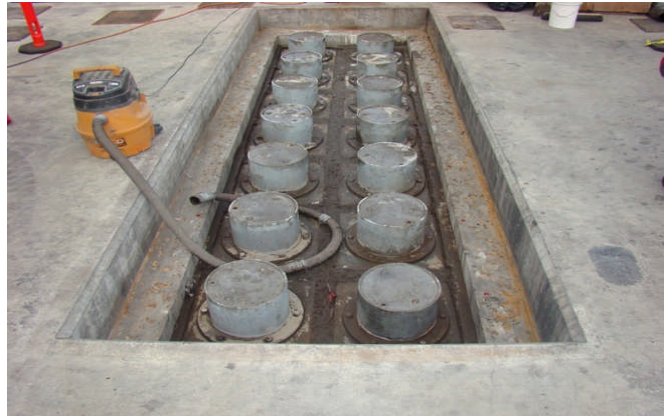
Removed cover slab of the E-Line cable tie down anchorheads to cleanup the concrete surface and place the neoprene pad.
